Geo-Environmental Study of Kaliasaur Landslide in District Rudraprayag of Garhwal Himalaya, Uttarakhand, India

Himani Bisht¹, Prof. D C Pandey²

Abstract: This paper deals with historical and massif landslide of Kaliasaur in district Rudraprayag of Garhwal Himalaya, Uttarakhand. The study area lies between the two districts of Uttarakhand state i.e., Pauri and Rudraprayag, belongs to lesser Himalaya of Garhwal Region. Kaliasaur landslide is located along Srinagar-Badrinath Highway about 15 km upstream of Srinagar at left bank of Alaknanda River. This slide is very important because it is located on NH-58 which is the only connecting road to outer world and affects daily life of the people. The main focus of the paper is to understand the nature of landslide and its causes, and finally with the help of the intensive field observation, the authors suggested treatment and concrete solution of this geo-environmental problem of the study area.

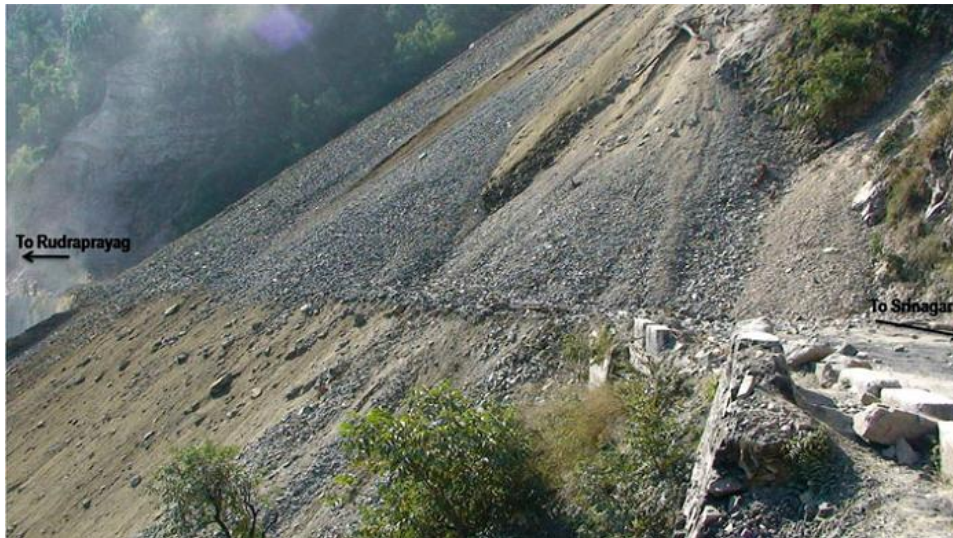
Blockage of the NH-58 due to slope failure in 2013 (Source: Indervir S. Negi, Kishor Kumar, Anil Kathait & P. S. Prasad, 2013)

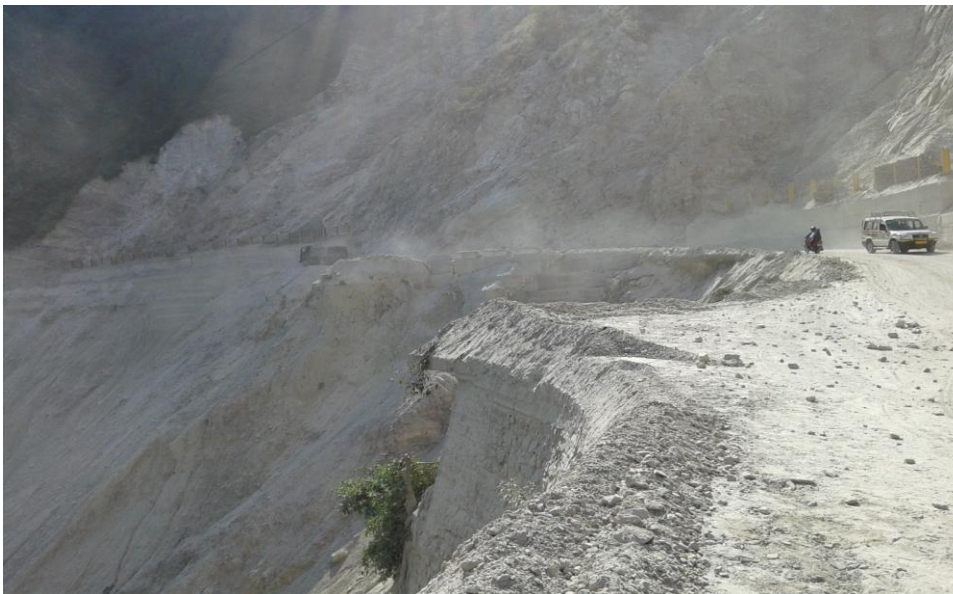
Condition of NH-58 in January 2016

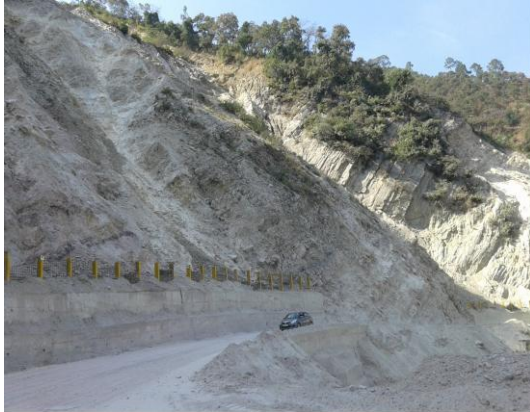
Show retaining wall made by BRO

There have been lots of attempts made by Boarder Road Organization (BRO) to protect this sliding activity by making heavy concrete retaining wall etc. In additional to the measures, there have been many other attempts done in the past and the mitigation process is still continued. Many activities are taking place for stabilizing or mitigating the slide like making of contour drains, grouting etc but none of them are giving fruitful results. Ultimately a dozer has been kept in the road for maintaining the transport and communication.

- Toe protection remains very much useful for such type of slides which are directly in contact with river meandering.
- Construction of massive RCC walls in different levels along existing slope shall also be useful to control the falling rock mass/fragments.

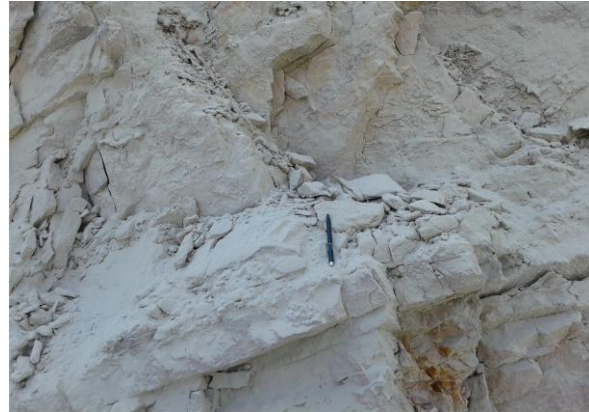
The top layer of the slide is highly weathered, broken rock pieces of quartzite mixed with clay developed due to attrition/movement of quartzite blocks. The area was dry during the field visit. It remains wet with surface runoff during rainy season. The slide creates lot of problems during monsoons due to which most of the time the road remains blocked for transportation.

Shows Quartzite rocks

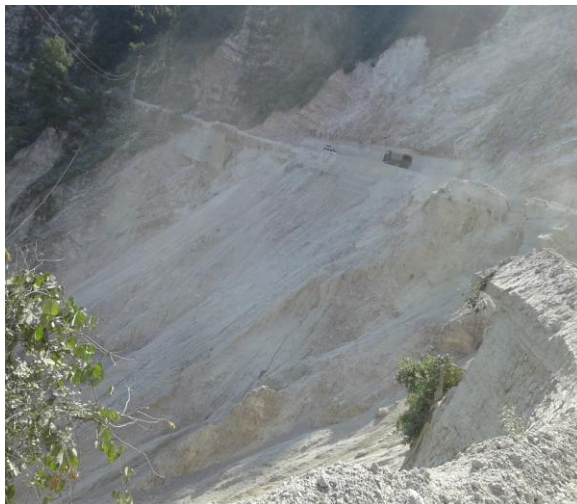
Shows pulverization of rocks

In general the governing slope of the slide varies between 60° and 70°. The entire slope present is devoid of natural vegetation. The highly weathered and disintegrated rock mass is the characteristic of this slope. The rock mass is bisected by three sets of joints. The prominent joint set is foliation which is governing the slope along where mostly slope failures have been observed. Due to attrition rock powder has been spread throughout the slope.

- Shotcretting with wiremesh along with anchoring may prove a successful tool towards controlling this slide.
- If possible, cement grouting can also be undertaken.

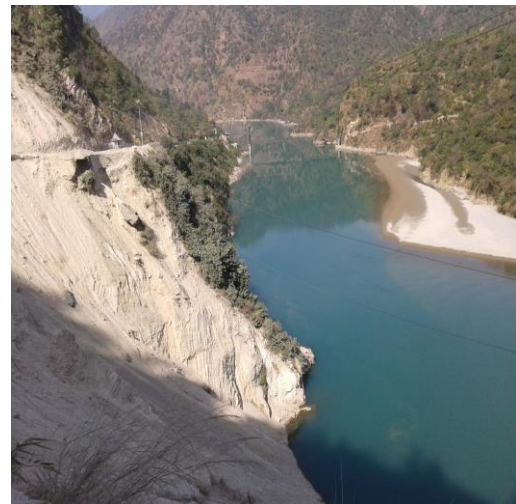
The entire slope of the landslide is along a rising trend of the hill which is further rising towards northeast. The entire area is partially covered with forest and wash materials are also noticed along the slope. The right bank of the river initially shows the depositional terrace followed by rising hills. The river has an acute meandering in this area just at the toe of the slide.

Alaknanda river at the toe of the landslide
